LESSONS LEARNED FROM AEGIS MEMBER CASE STUDIES

AEGIS 2018 PHC

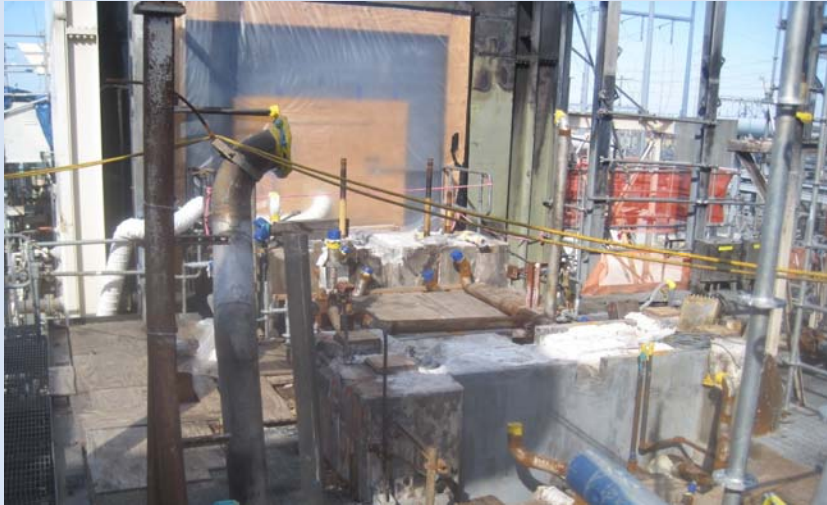
Coupling between HP and IP/LP turbine loosened, creating vibrations damaging and eventually liberating 42" LSB with ensuing fire

STG mechanical failure event resulted in all coupling bolts failing in ductile tension overload (not fatigue), raised the stress levels on L-0 section that caused multiple blade failures, all instrument pickup mounts failed, damaged control valve, stop valve, and damaged multiple stationary devices. RCA identified most likely cause was that failed coupling bolts initiated the event, which allowed the L-0 dormant crack(s) to propagate.

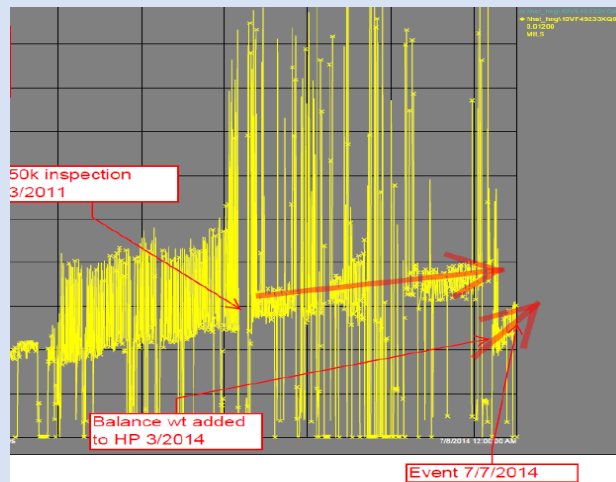
CLAIM EXAMPLE – VIBRATION HISTORY

- 2013** Bearing #3 was raised to add more load to stabilize bearing from high vibrations with little success
- 2014** **March-April** – added a balance weight that changed slope of vibration increase ~5x
- 2014** **May 24** – Loss of auxiliary power caused loss of cooling water and condenser back pressure increase during steam turbine trip, allowing STG speed >3600 rpm and vacuum >8 in HgA for approximately 450 seconds. This was the most likely cause for an existing erosion pit to grow from zone ~ 0.025" to 0.126" on the LSB blade and arrest. The crack remained dormant with exclusion running stresses
- 2014** **June** – OEM issued the first release of a detailed coupling assembly procedure as a result of other fleet coupling failures
- 2014** **July** – Last stage blade liberated

- Review of vibration data showed a significant phase angle shift after the 2011 major inspection, indicative of coupling loosening
- Turbine hood sprays were moved further from turbine to reduce droplet erosion
- The sister unit on adjacent power block was found with loose coupling bolts on HP-IP/LP coupling
 - OEM increased the coupling bolt preload spec by as much as 40%

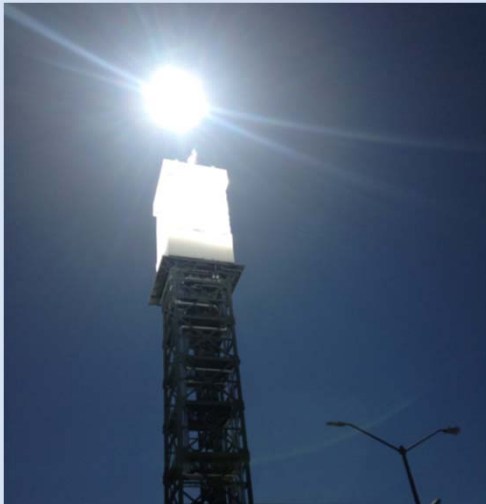
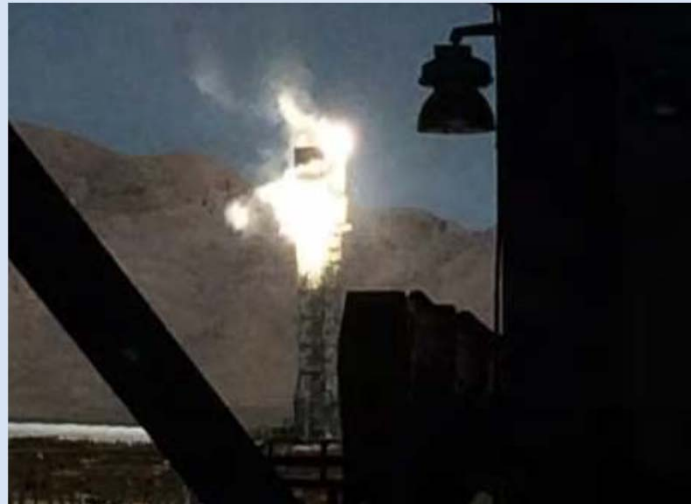
- Fire in generating tower
 - Boiler = 2,646 psig, 1,013 F
 - 450' high
 - Heliostat control system malfunction – mirrors focused on tower
 - Damage to cabling, instrumentation
 - Claim open – property damage paid to date: \$7 million, business interruption within waiting period
 - Deductibles = \$100,000 property damage, 45 days time element
 - Subrogation – tbd

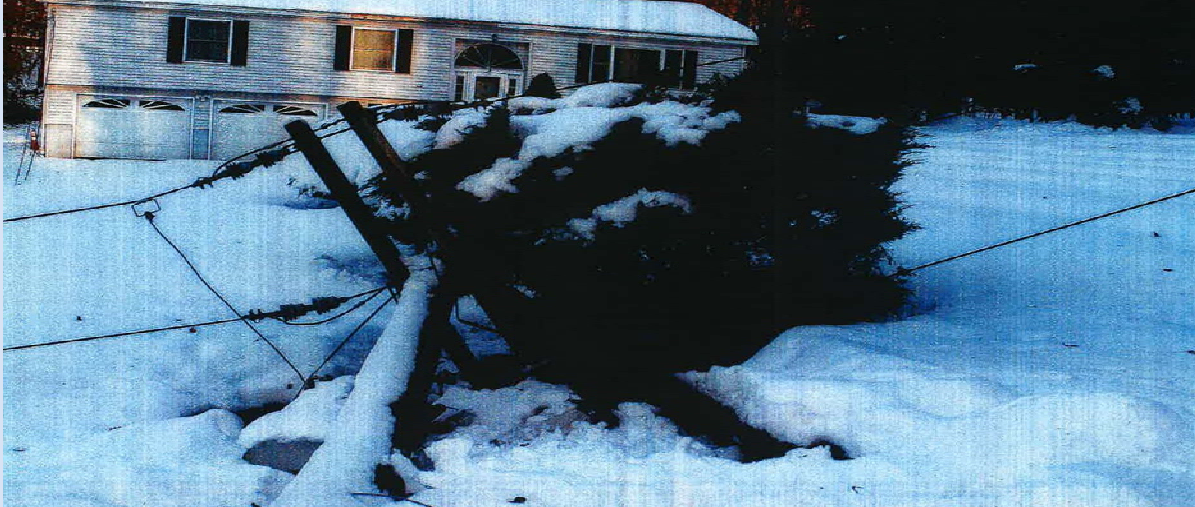
- Decedent was walking her dog when she was struck in the head and killed by a falling utility pole
- Accident occurred during an early season snowstorm with 30 mph winds
- Large tree outside of the insured's right-of-way on adjacent property fell onto the insured's wires mid-span
- Force of tree falling on line caused pole to break at the base

- Pole was secured and removed
- Inspection revealed a significant portion of the pole was rotted near and below the ground line
- Insured's pole expert opined that the pole should have been taken out of service or otherwise reinforced prior to the accident
- Tree that landed on lines also rotten at the base
