# Hardfacing Alloys Cracking and Disbonding in Steam Valves

## A Guide for AEGIS Members

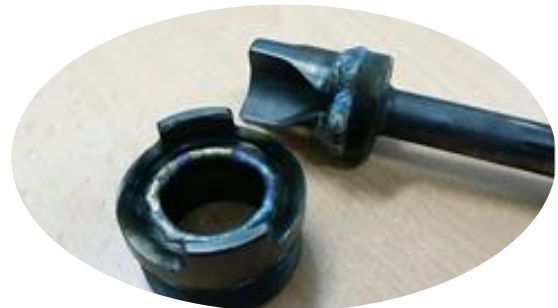
Hardfacing is directly weld-applied to the base material of a valve body or disc and then machined to a smooth finish. In power generating facilities, hardfaced gate valves are typically used for isolating steam lines between the HRSG/boiler and turbine. Stellite, a common hardfacing material, has been successfully weld-applied to Grade 22 (2.25% chrome) and Grade 11 (1.25% chrome) valve components for more than 25 years.
