One Year Later: Utility-Related Losses: What We've Learned and What You Should Know

Vice President – Loss Control and Division Head  
*AEGIS Loss Control Division*

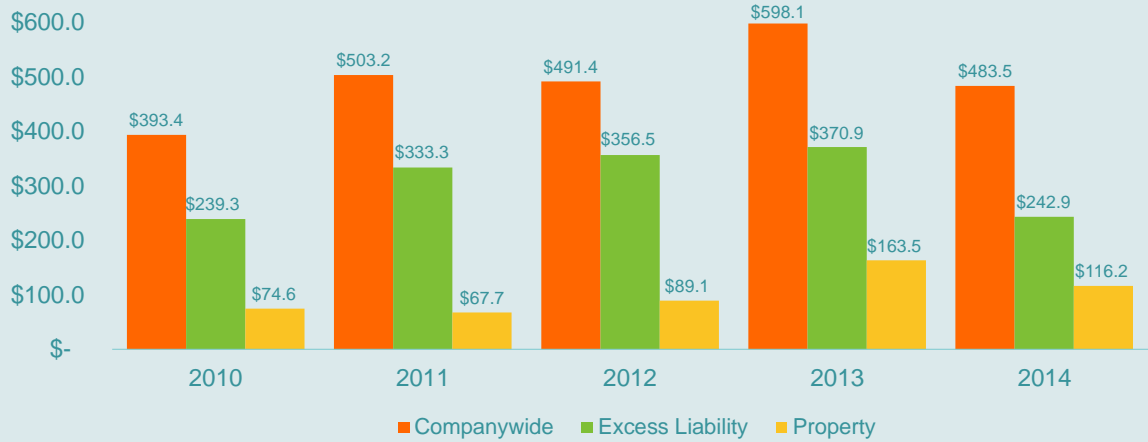
### Annual Paid Amounts

5 Year comparison

In millions

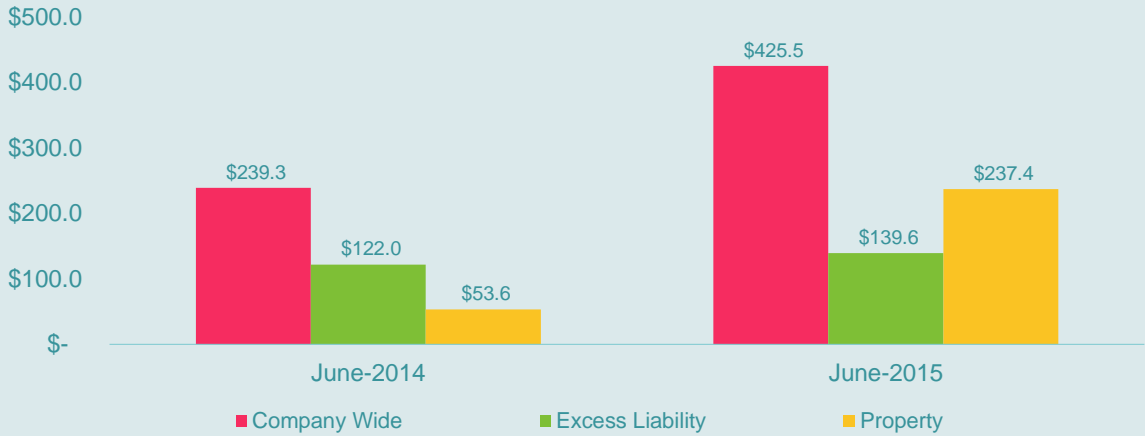
### Paid Amounts

6 month 2014 / 2015 comparison

In millions

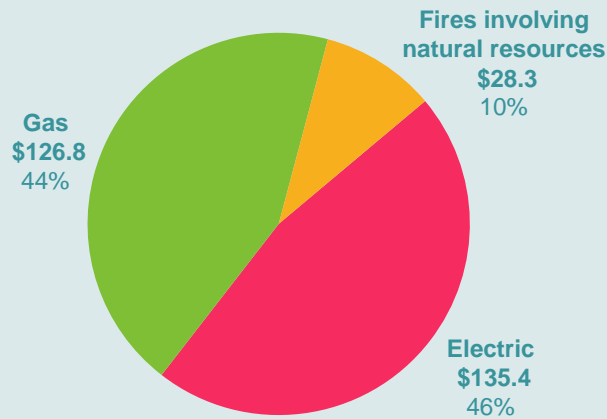
### Excess Liability Paid

1/1/2014 – 6/30/2015

Gas, electric, fires involving natural resources

In millions

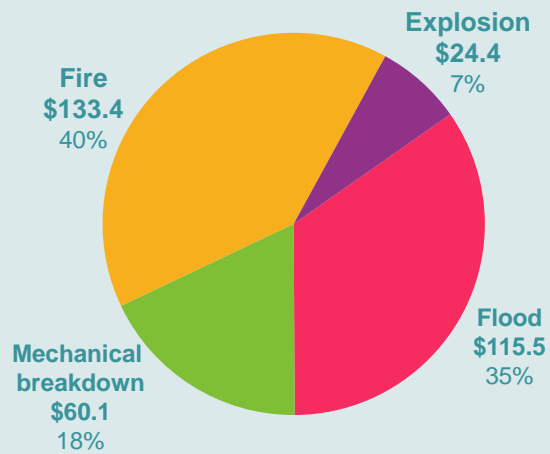
## Property Paid

1/1/2014 – 6/30/2015

*Explosion, fire, flood, mechanical breakdown*

In millions
