Policyholders' Conference

Casualty Losses – Lessons Learned

Electric Guy Wire Contact Incident

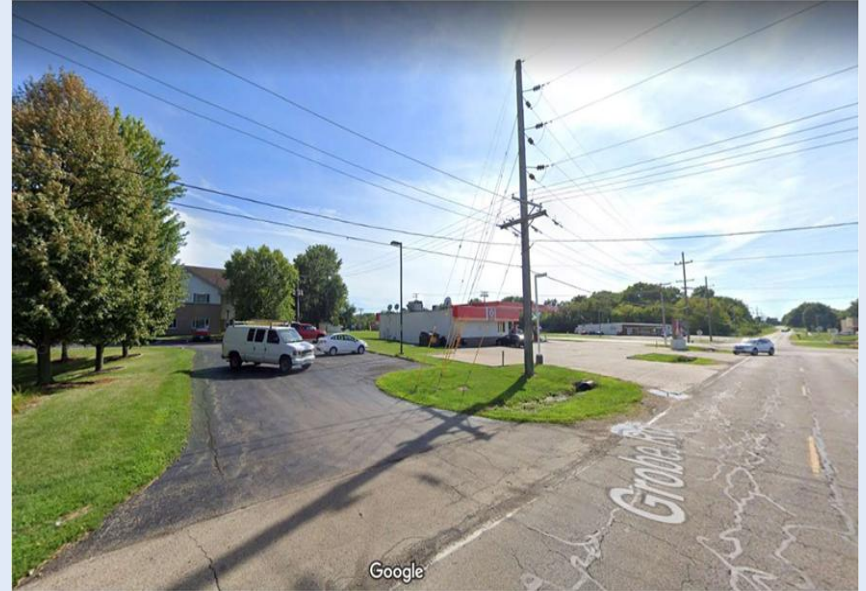
- Subcontractors for CATV company, working on a utility pole pulling fiber line inadvertently put the boom of their truck in between the guy wires
- The workers may have unwound the guy wire wrap at the anchor, causing it to swing free
- The loose guy wire, struck the 12kV primary line, contacting the secondary electrical line and the CATV cable
- The energized guy wire contacted the workers resulting in serious injuries

The contractor inadvertently placed the boom of their truck in-between the guy wires

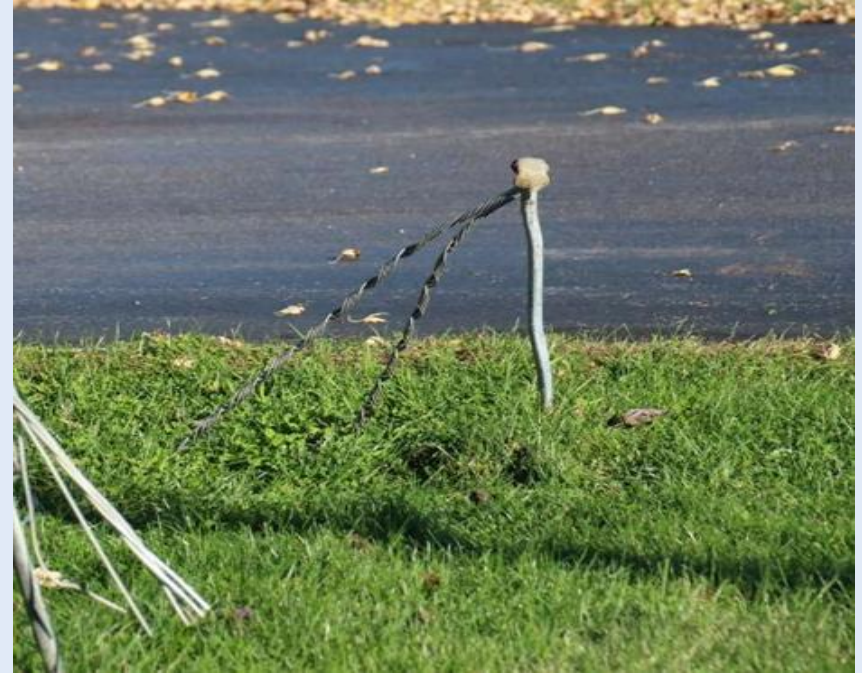
- Plaintiff asserted that the installation of guy wires and insulators violated the National Electric Safety Code (NESC)
- Defense conceded that improper placement of the guy wire insulators above the 12kV line was improper
- This placement violated both the utility's own Construction Standard and NESC Rules 279
- Utility's defense claimed that the contractors purposely unwound the guy wire
- No definite evidence that the wire was unwound
- Plaintiffs argued guy wire was not cut but became unwound due to improper securing

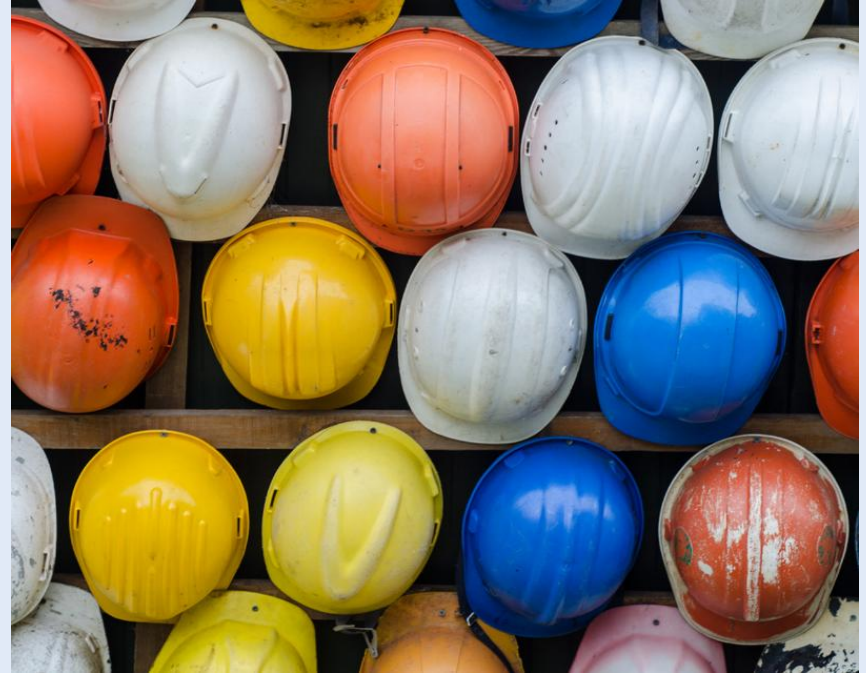
- Utility was on notice of NESC 279 violations relating to guy wire insulators after a 2009 audit
- Conducted an all-hands meeting for maintenance inspectors and provided refresher training to its maintenance inspectors
- Prior to the accident, the utility performed regularly scheduled circuit inspections of the high voltage lines at the subject utility pole from 2009 to 2016
- The inspection records revealed no reported guy wire insulator problems at this location
- The inspector's work became an issue in the case

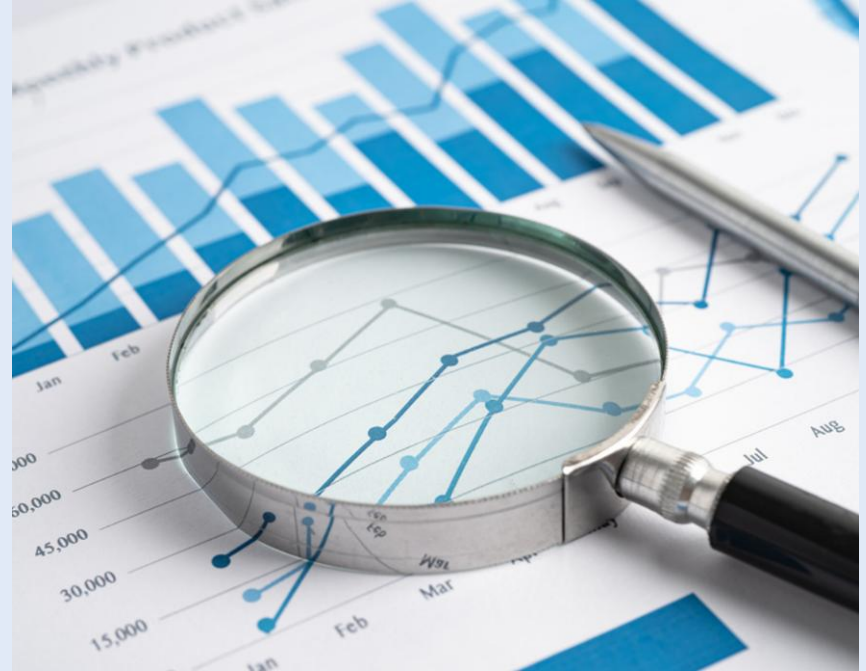
- Utility's maintenance records revealed multiple instances of guy wire insulator placement issues which remained unaddressed for decades
- The persistent violations, despite the commission audit findings, suggested a systemic failure in safety compliance
- An audit following the accident identified numerous similar guy wire insulator placement violations within the service area
- Widespread violations indicate a broader issue with the utility's historical installation practices and maintenance procedures
- Opened the door to punitive damages

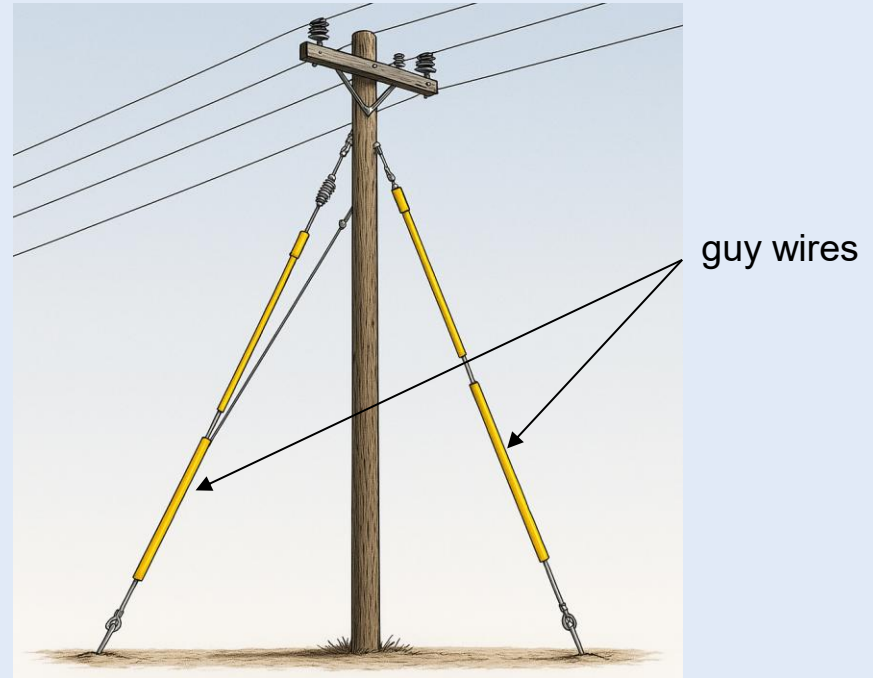
- Anchor guys provide a potentially dangerous electrical path to ground if not constructed correctly
- Correct construction that complies with NESC rules 215.c and 279 is best defense against creating a dangerous situation
- Work orders issued with correct size and number of guy strain insulators
- Field verification and quality assurance that facilities constructed per standards and per the work order
- Inspection practices and corrective action

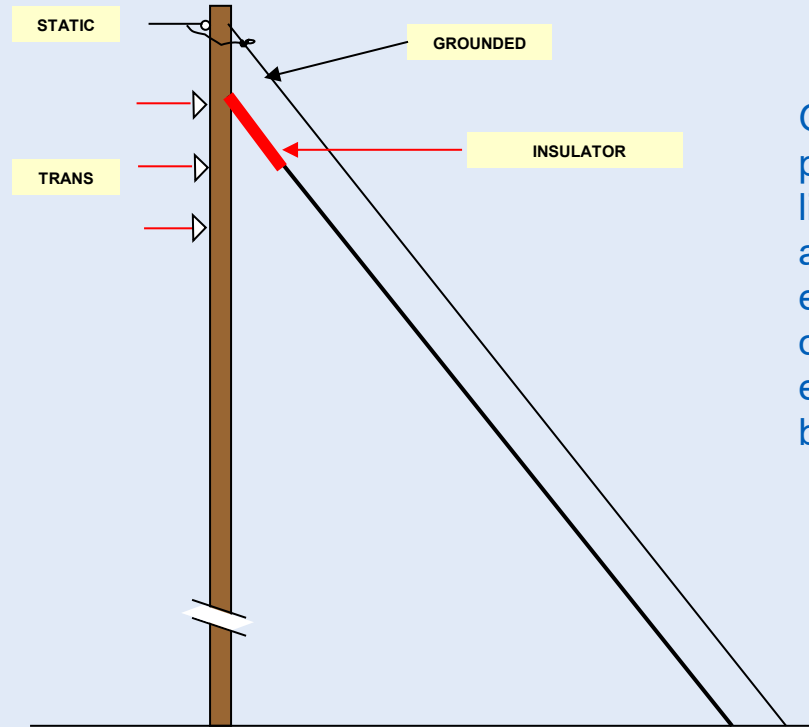
Does this meet the code?

Is it safe?

Guy insulators shall be positioned so as to limit the likelihood of any portion of an anchor guy becoming energized within 8 ft (2.45 m) of the ground level in the event that the anchor guy becomes slack or breaks

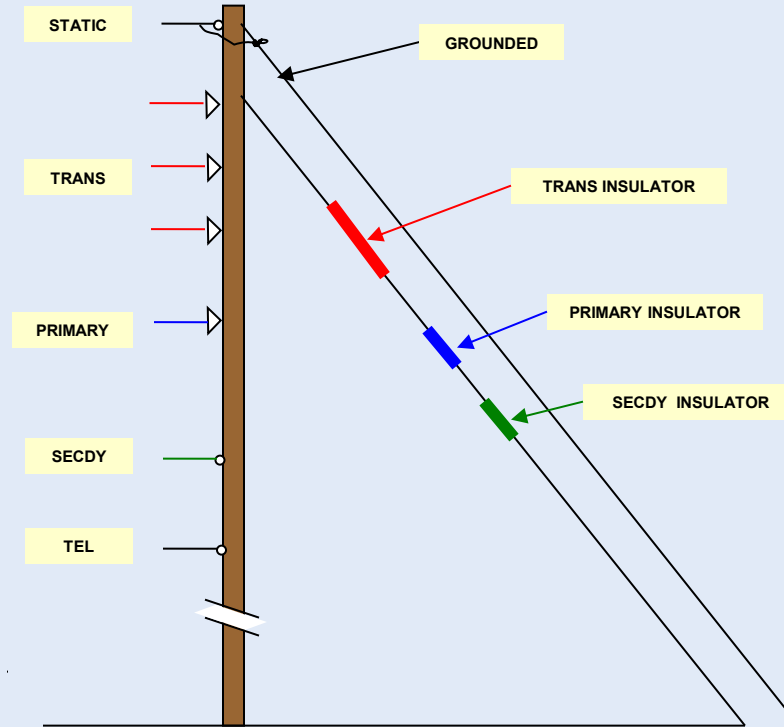
Guy insulators shall be positioned so as to limit the likelihood of any portion of an anchor guy becoming energized within 8 ft (2.45 m) of the ground level in the event that the anchor guy becomes slack or breaks

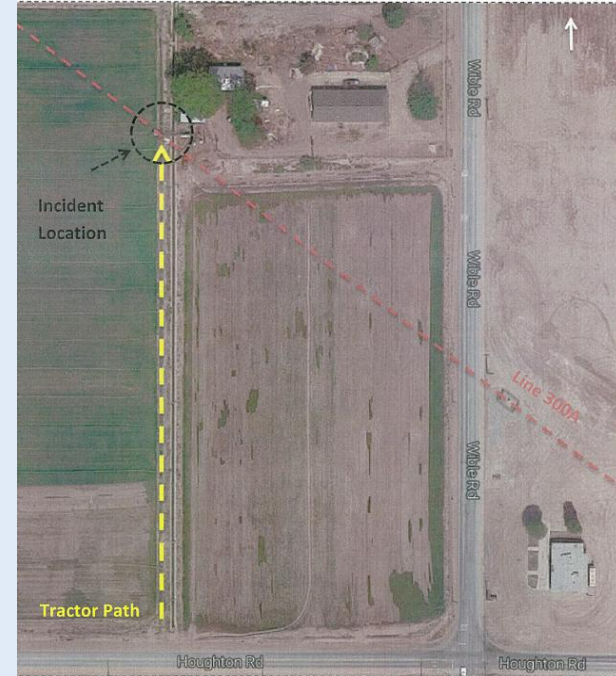
- Farm owner hired management company → contractor for deep ripping
- 36-inch natural gas transmission pipeline ran under field
- Contractor notified utility via 811, received USA tickets
- Utility marked line; contractor delayed project beyond expiration
- Tractor operator forgot to lift ripping shank → line puncture
- Massive explosion/fireball 200+ ft tall, visible 6+ miles away
- Operator fatally injured; nearby home badly damaged

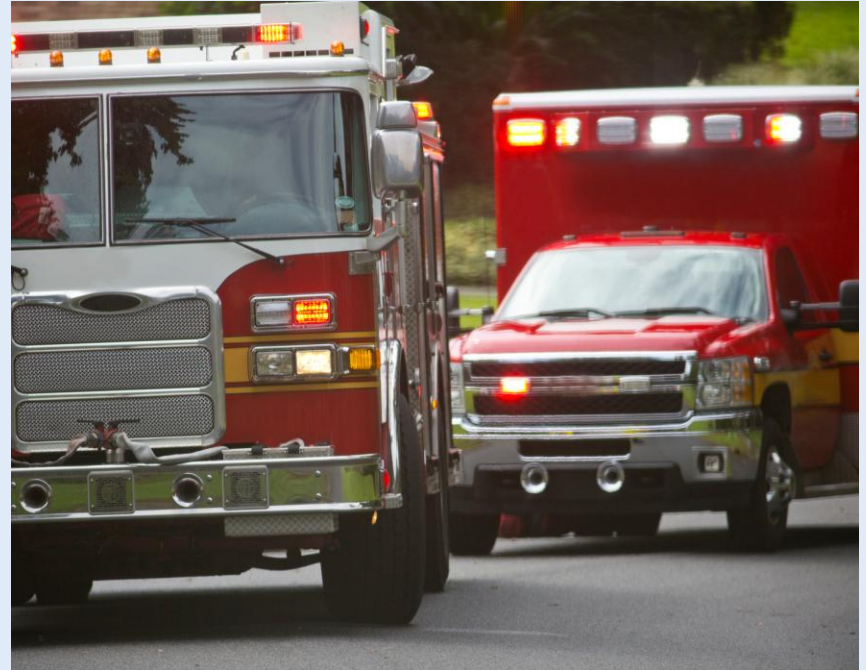
- Allegations against the utility included failure to
 - Properly mark the gas line
 - Ensure markings remained visible
 - Issue adequate safety warnings
 - Provide proper safety support to contractor
- OSHA investigation findings excavator found to be at fault
- Contractor and farm management issues
- Communication breakdown
- Aerial patrol evidence

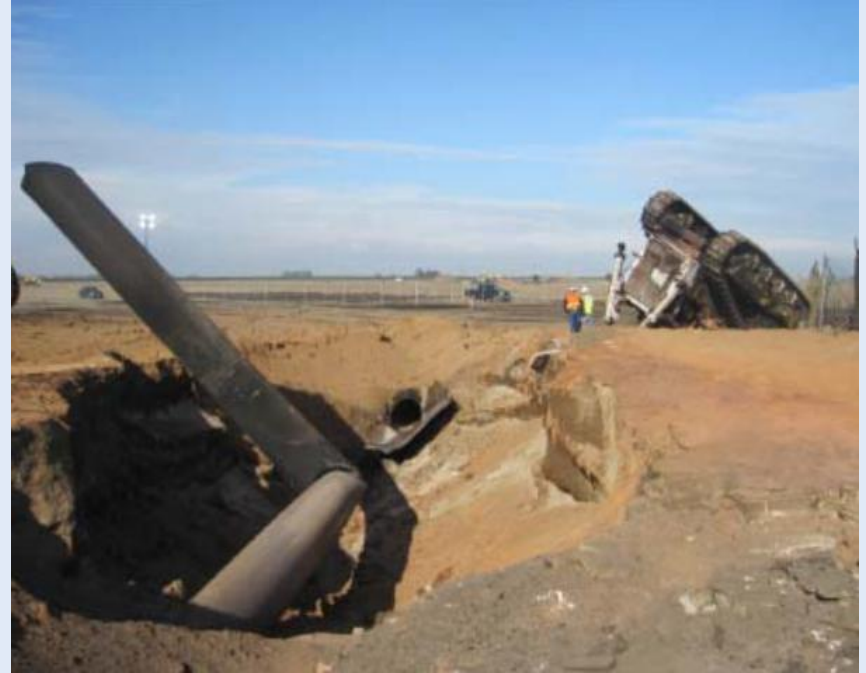
- PUC investigated historic issues with the locate and mark program
- Broad admissions undermined exculpatory evidence
- Expert reports relied on discredited documents
- Utility admitted that a late response was the contributing factor to prior incident
