Policyholders' Conference

Property Losses – Lessons Learned

Example 1 – Solar Claim

Example 3 – Transformer Claim

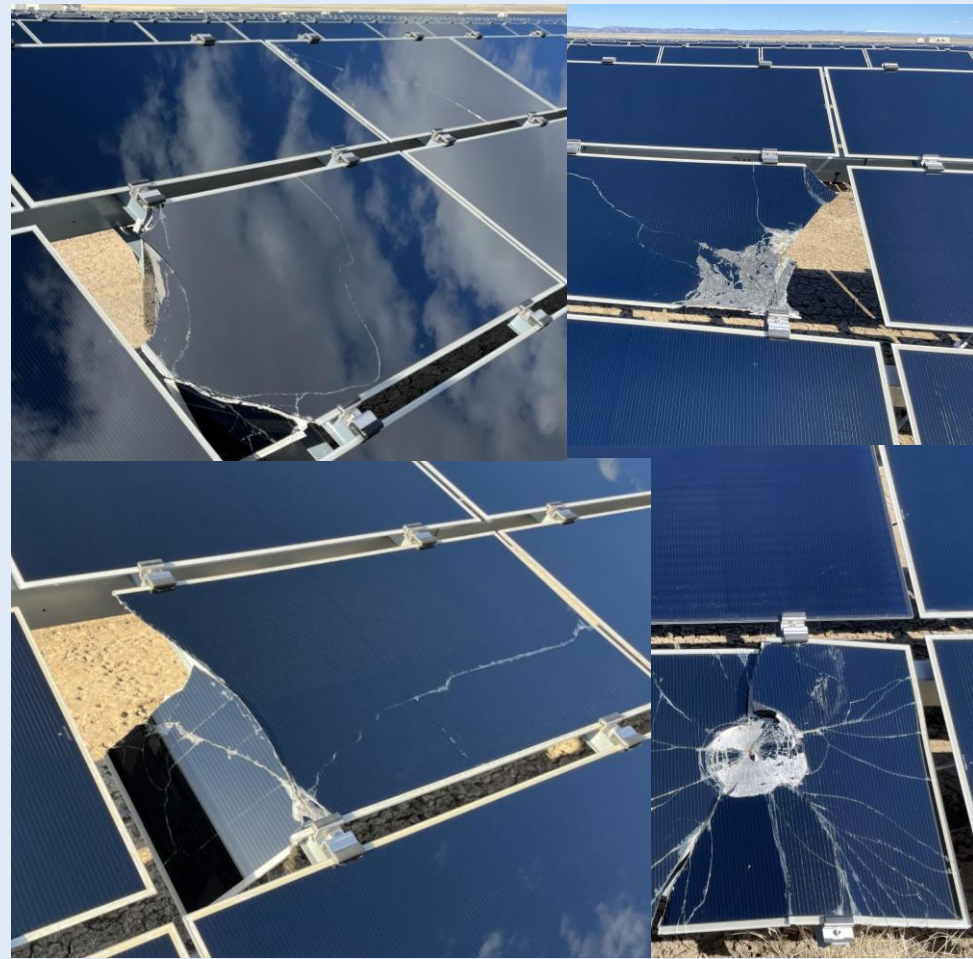
- Significant hailstorm in Western USA, 2023
 - 30MW Photovoltaic (PV) solar plant
 - 250-acre site with 483,000 PV modules
 - First Solar Series 3, FS-377
 - 68,000 modules damaged (14% of site)
- Challenge of like kind replacement – Series 3 and 4 now obsolete (debut c. 2013 – 2017)
- Series 3 and 4 have same dimensions, but Series 4 has higher output – can't be mixed
- Sourced 55,000 Series 4 FS-4117 modules at a steeply discounted price
- \$6.5M preliminary PD estimate using Series 4

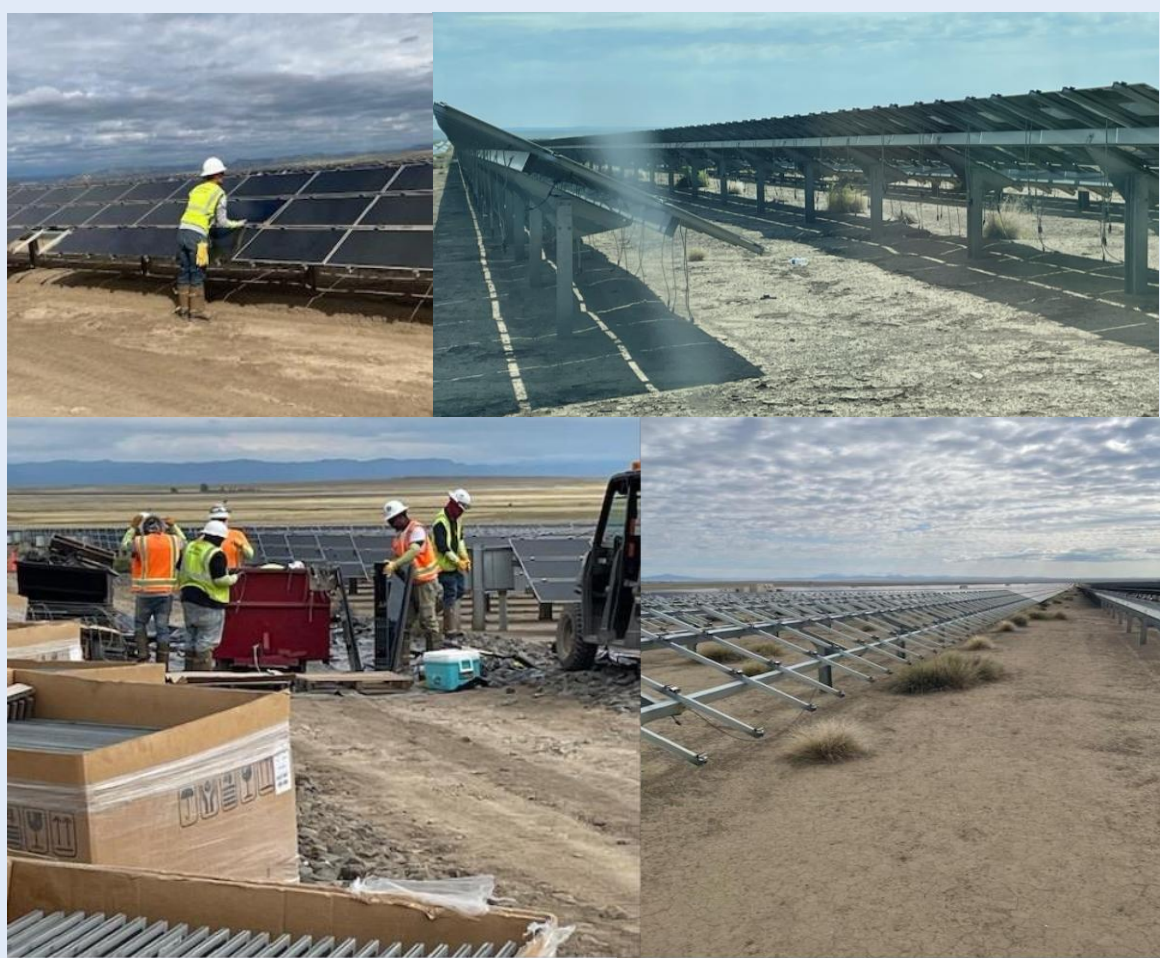
- However, labor-intensive work required to reposition modules in compatible series (Series 3 with Series 3 and Series 4 with Series 4)
- 55,000 new Series 4 modules installed and approximately 68,000 existing Series 3 modules relocated
- Labor-intensive = Labor-expensive!
- PD escalated from \$6.5M to \$10+M, primarily labor driven

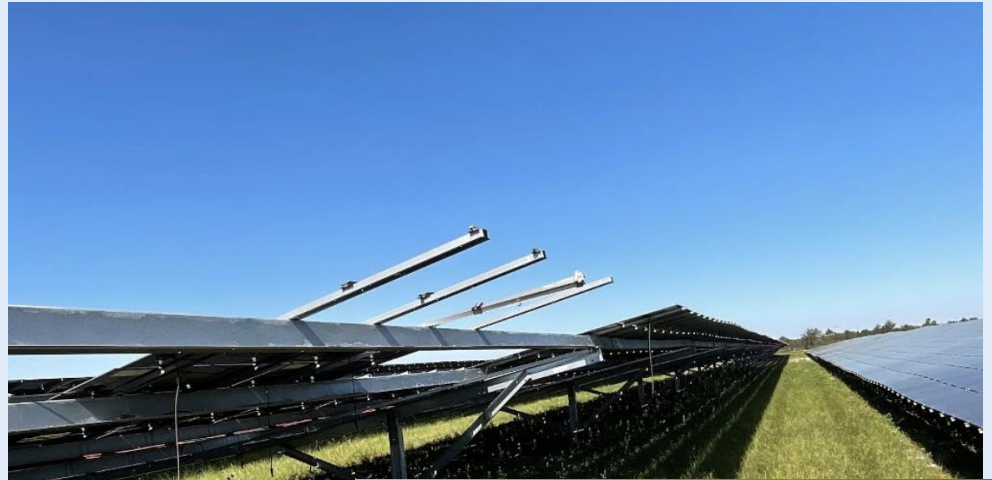
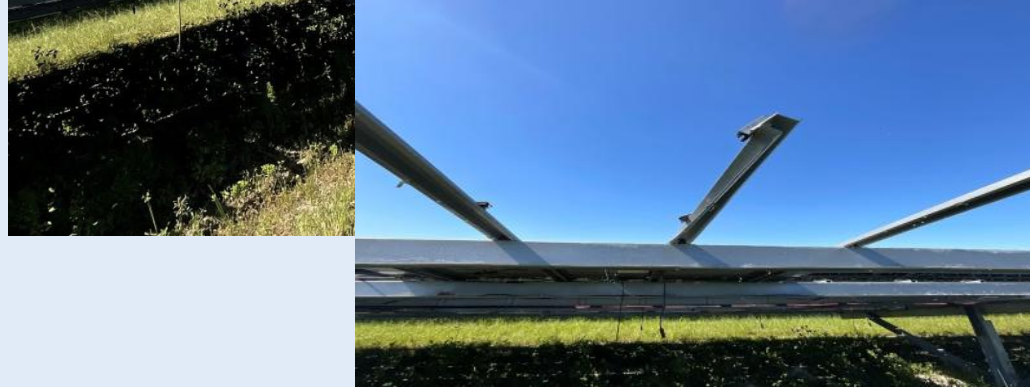
- Named Windstorm – Florida 2024
 - **Multiple** 75MW PV solar plants
 - 500-acre sites, 700,000 PV modules
 - First Solar Series 4 panels
 - Mix of single axis tracking and fixed racking
 - CAT 3, max sustained winds 120 mph
- Challenge of like kind replacement – Series 4 now obsolete (debut c. 2013 – 2017)
- Preliminary PD estimate – \$25M plus \$19M for racks
- Was able to source used like kind Series 4 modules

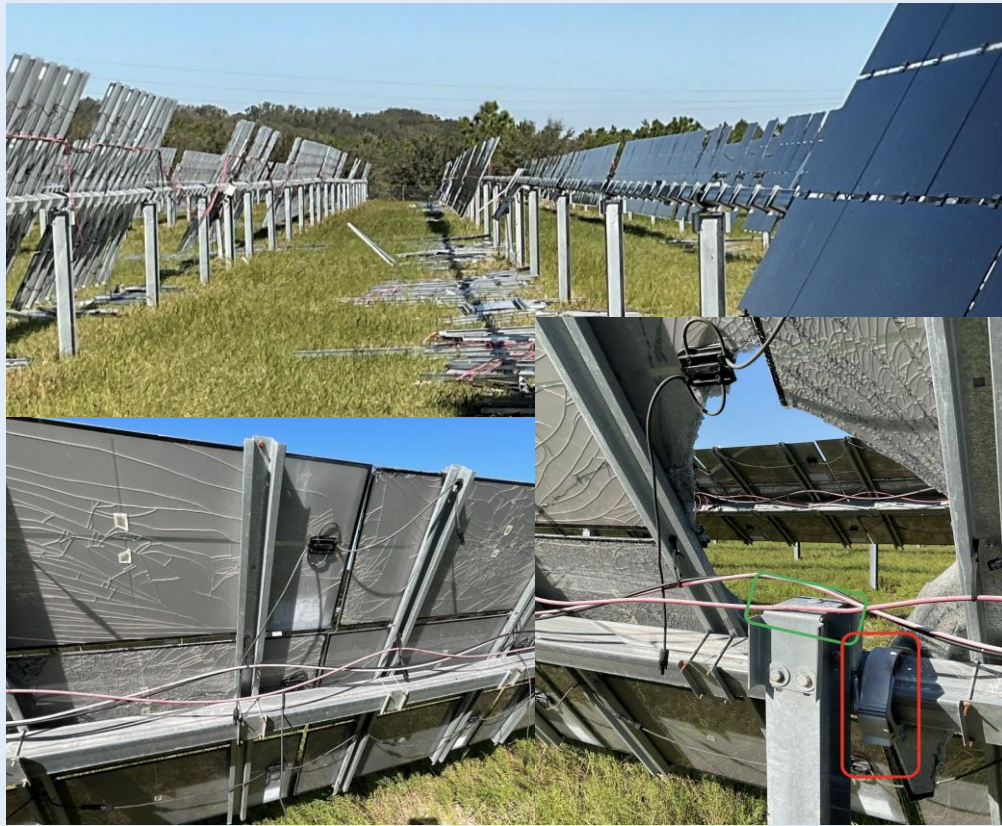
- Root Cause Analysis
 - Tracking systems were reportedly designed to withstand windspeed of 140 mph
 - Max wind speeds at the sites were upwards of 60 mph with gusts up to 85 mph
 - Tracking system's purlins were under-sized and not sufficient to handle wind forces
- Subrogation deemed nil due to contractual terms
- Tracker company honored warranty for repair or replacement of the tracking systems (not modules)
- Preliminary PD estimate using Series 4 \$25M plus \$19M for trackers and racks
- Sourcing of Series 4 panels coupled with warranty cover on trackers and racks significantly reduced the exposure, potentially to a range of \$5M

- **Fastener types**
 - Through bolt fasteners with locking nuts are preferred – clips and clamps speed install but don't provide resiliency
- **Tracker Configuration**
 - Double Portrait (2P) tracker configurations are a significant design challenge. OEMs are universally moving away due to these low wind speed failure events
- **Stowing protocols**

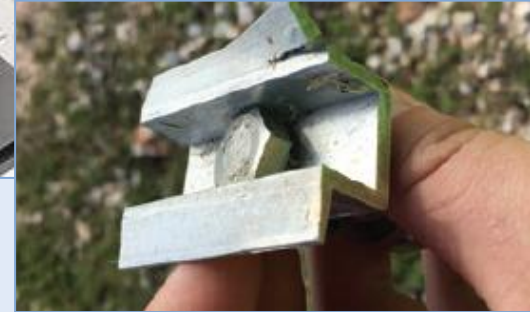
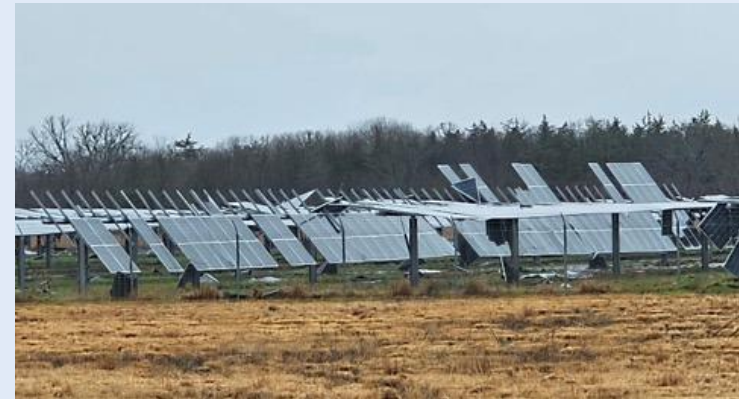
Below design wind speed failures sum up the bulk of the events and these are good examples of what we are seeing

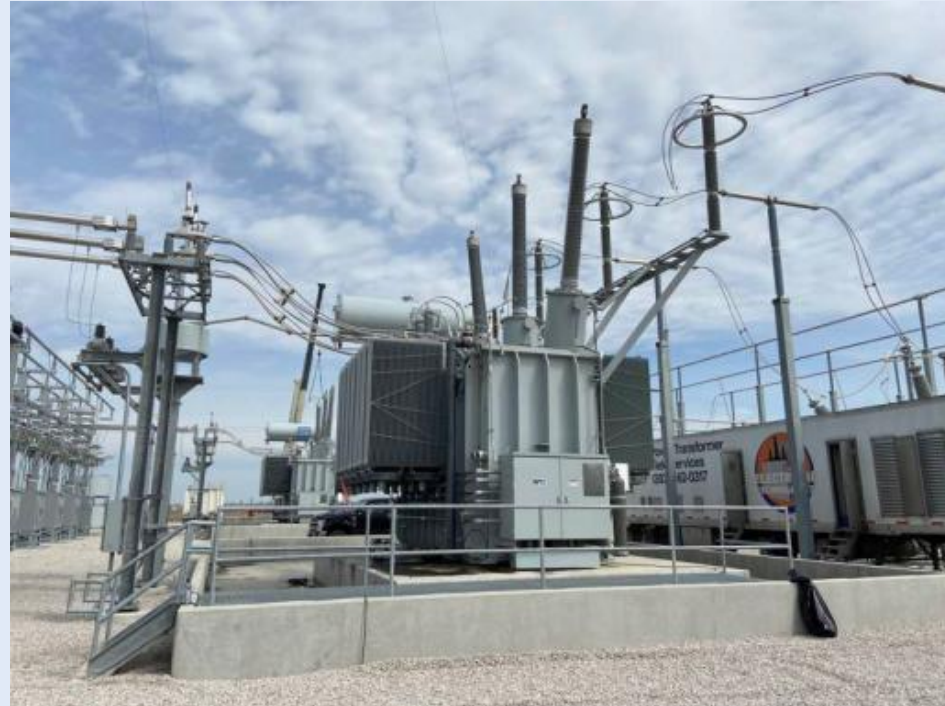
- 300 MW Windfarm
 - 139 Vestas V110-2.0MW and V120-2.2MW
 - Site equipped with two, 165MVA Main Power Transformers (MPT)
- Both MPTs failed within three (3) days of each other, site derated then non-operational
- Failures occurred during first year of multi year warranty, transformer repair costs covered
- Single leased replacement transformer located and operational 4 months post loss – mitigated some of the business income loss
- MPT-1 had repeat failures during testing, not back in service for 19 months
- MPT-2 returned to service 9 months post loss

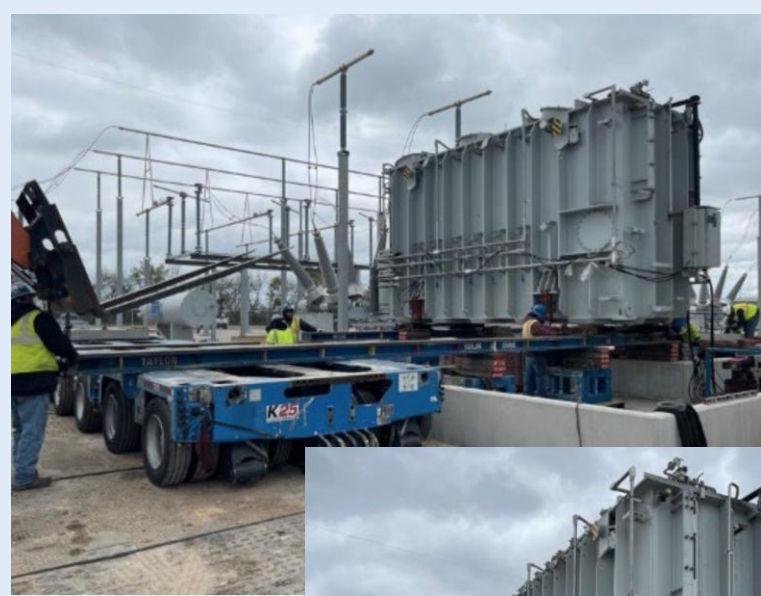
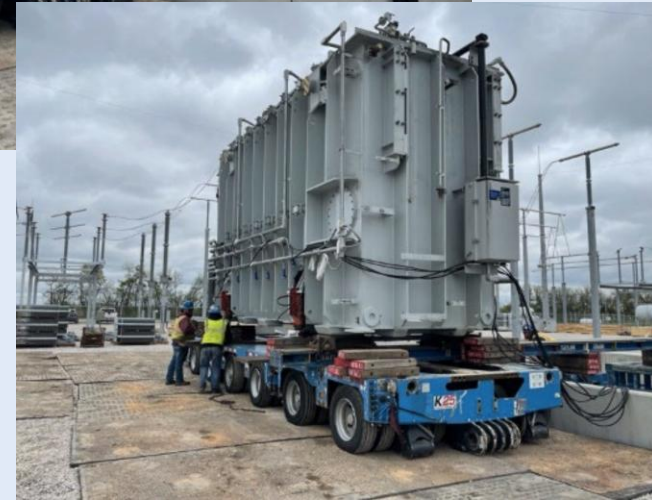
- Property Damage claim - \$1.5M
 - Transformers covered under warranty
 - Substantial costs for preservation of property. Installed windsocks to mitigate wind turbine blade damage. Turbines unable to yaw into wind without power
- Business Income loss estimated at \$33M including generation revenue and Production Tax Credits (PTCs)
- Leased MPT covered under Increased Cost of Working (ICOW) at an additional cost of \$3.6M
- Leased MPT saved another \$11M in Business Income loss

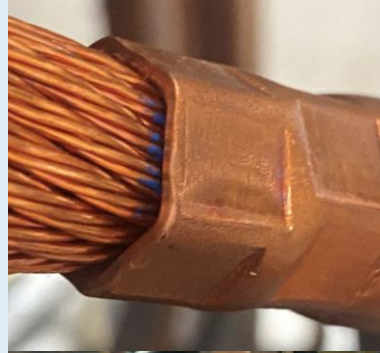
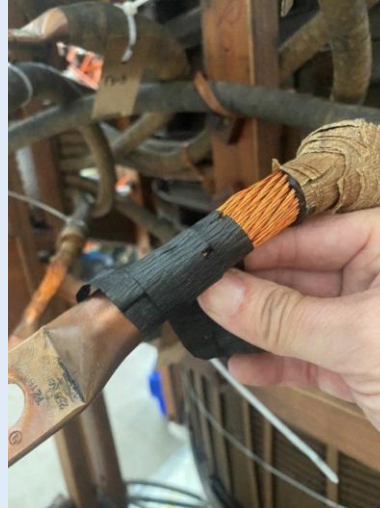
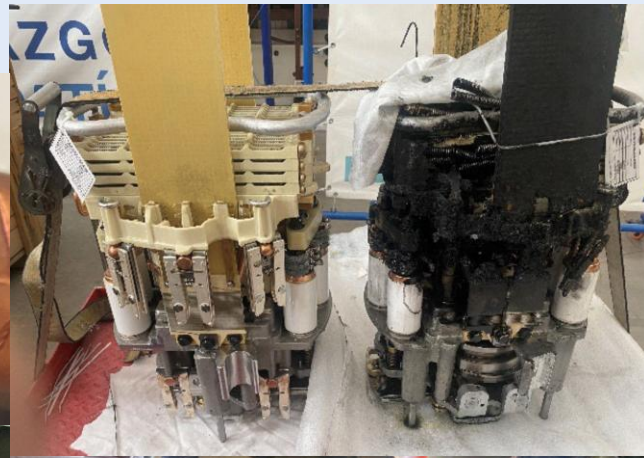
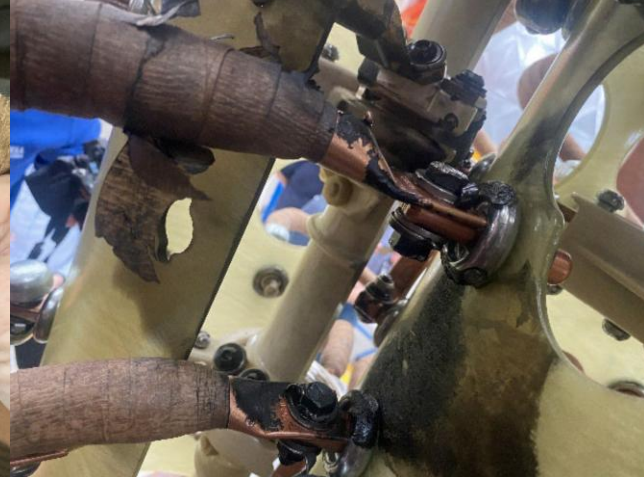
- Lack of quality assurance, quality control
- Conductors attached to tap changer spaced too close to one another resulted in arcing
- Other leads were spaced well below the minimum clearance

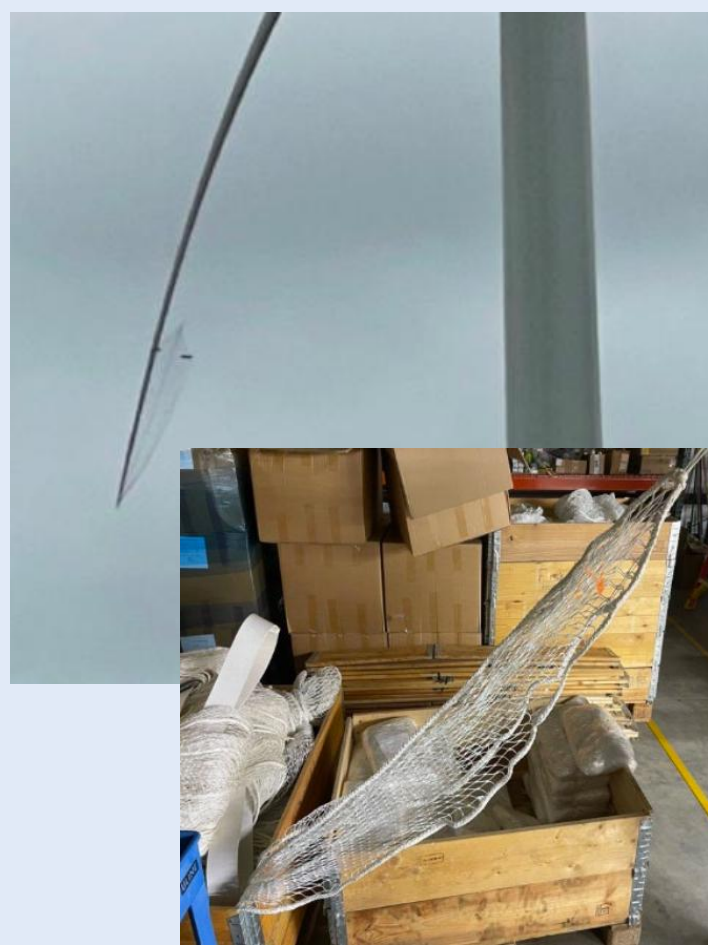
- An outlier loss
 - Installed redundancy at roughly 50%
 - Normally consider this to be a conservative set up
 - Lost Estimate consideration would not include failure of both Main Power Transformers
 - Only mitigation for an event such as this is a spare transformer or possibly a contractual contingency plan
- Without grid power available turbines cannot yaw into the wind
- Required windsocks on all blades to mitigate damage due to edgewise vibration
- Enormous undertaking considering three blades per turbine and on 139 turbines

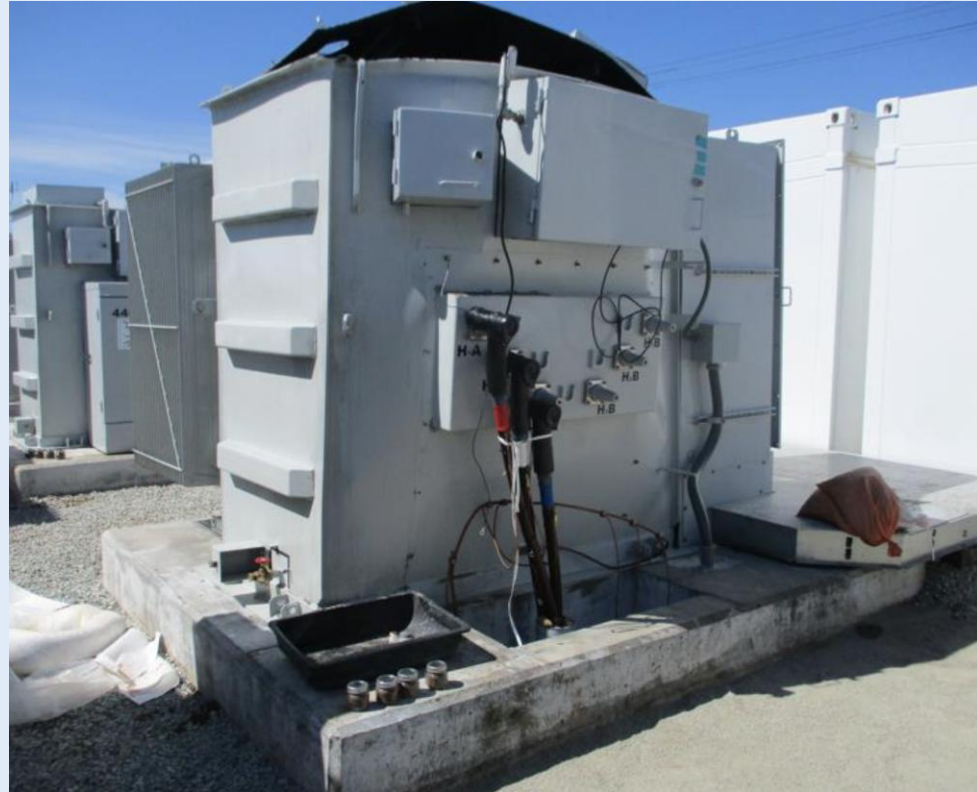
- 200MW Battery Energy Storage System (BESS)
 - Builders Risk Project
 - Medium Voltage Transformer failed upon being energized
 - Collateral damage to adjacent transformer
 - Root Cause Analysis underway
 - A 2nd transformer failed during commissioning two weeks later
 - Property Damage costs estimated at \$750K per unit
 - Delay in Start-Up (DSU) loss possible

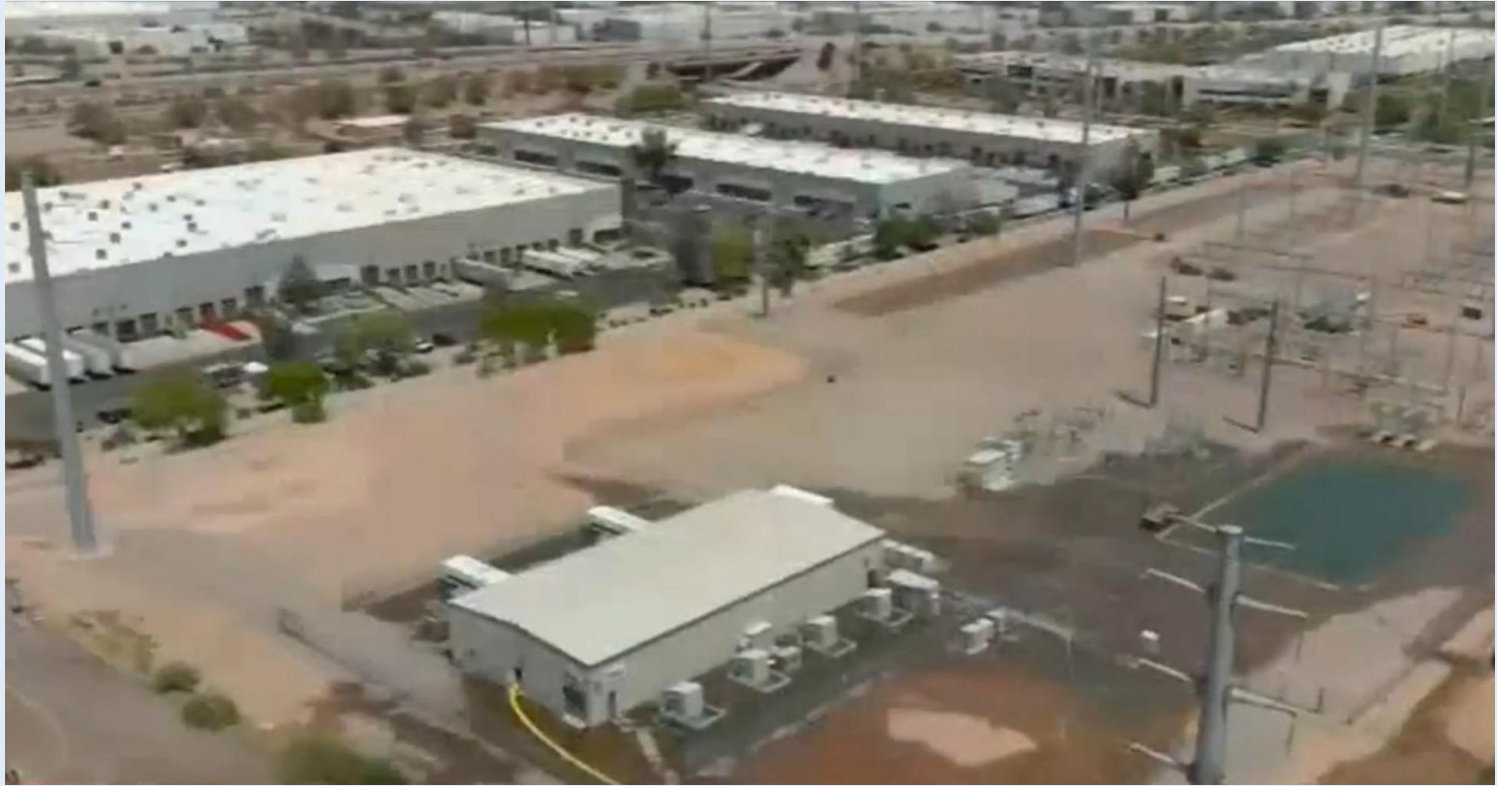
- 10MW / 40 MWH BESS
- 3-year-old facility
- Thermal runaway event due to likely internal fault in cells
- Sprinkler system activated over an 11-day period to control flare-ups
- 2 million gallons of water discharged
- Fire, heat, smoke, and water damage to 100% of modules
- Replacement modules 18 month lead time
- Property Damage ~\$20M
- Business Interruption ~\$3M

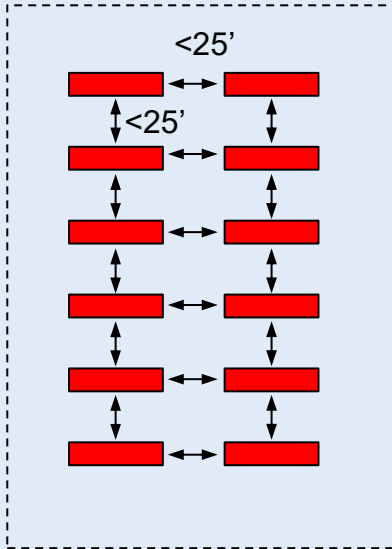
Site 1

PML = MFL = All Containers*

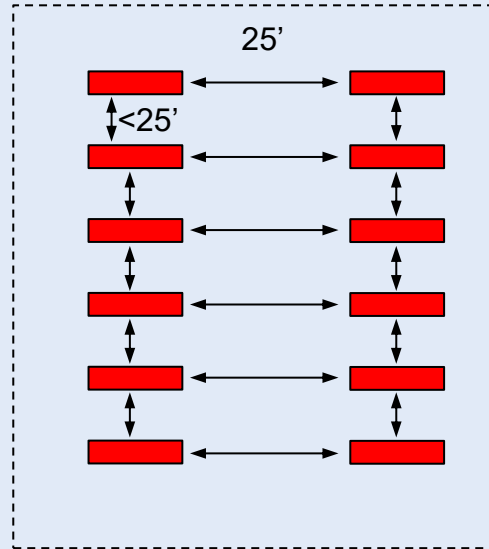
Site 2

PML = MFL = 6 Containers

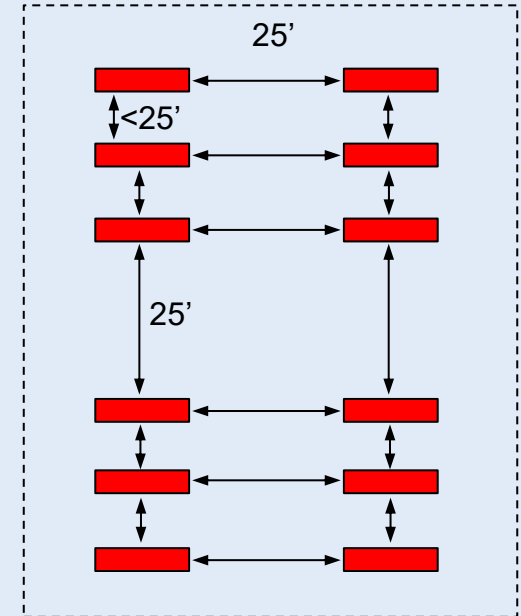
Site 3

PML = MFL = 3 Containers
