LESSONS LEARNED FROM AEGIS MEMBER CASE STUDIES

AEGIS 2018 PHC

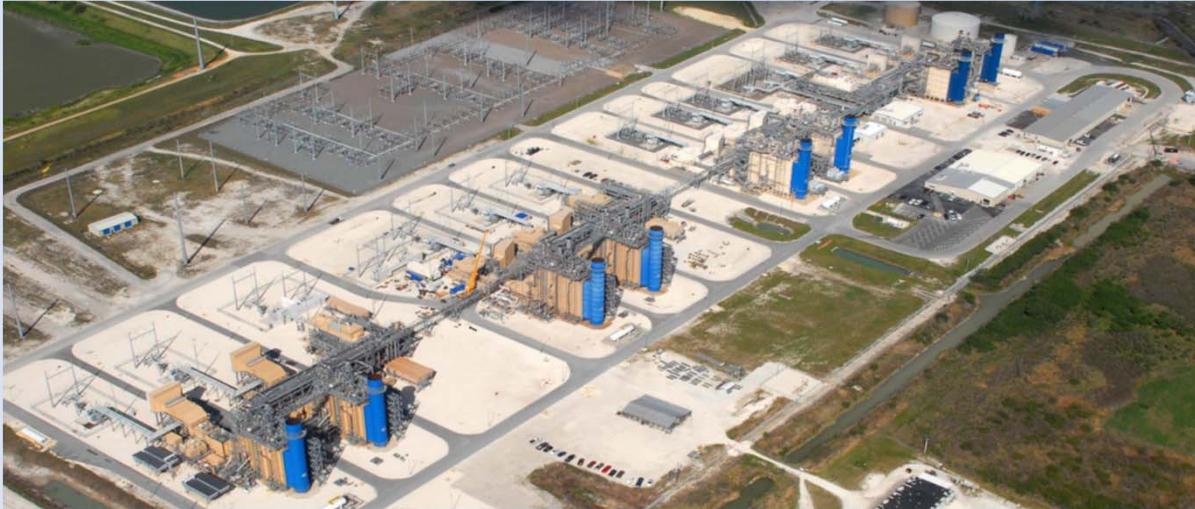
- Steam turbine generator (STG) – mechanical breakdown
- 188 MW Siemens Westinghouse HE series (high pressure with combined intermediate pressure / low pressure), axial single flow, condensing steam turbine
- Last stage blade (LSB) failure – Unit experienced LSB liberation which caused significant damage to the HP turbine, IP/LP turbine, generator bearings and foundation

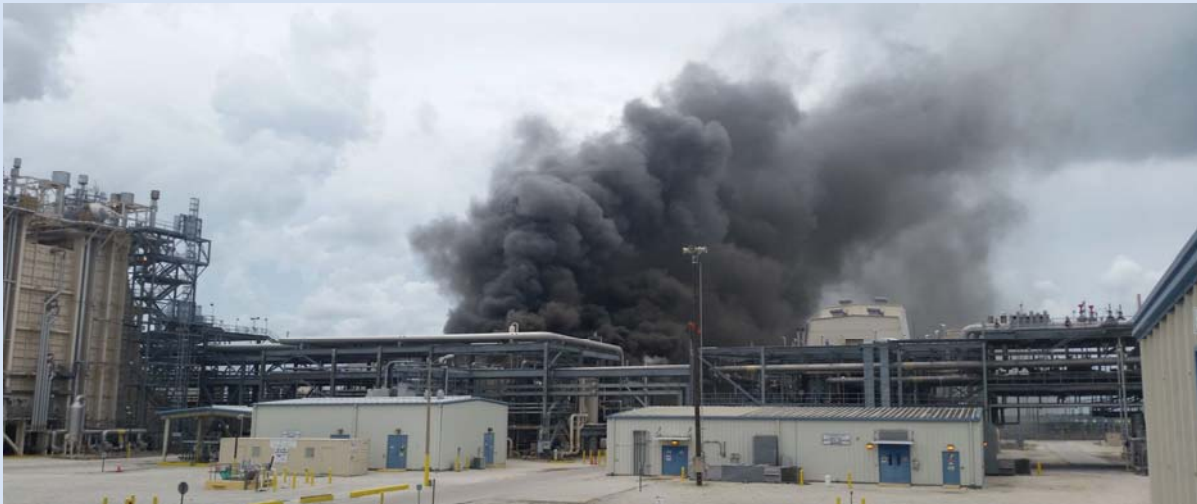
STG mechanical failure event resulted in all coupling bolts failing in ductile tension overload (not fatigue), raised the stress levels on L-0 section that caused multiple blade failures, all instrument pickup mounts failed, damaged control valve, stop valve, and damaged multiple stationary devices. RCA identified most likely cause was that failed coupling bolts initiated the event, which allowed the L-0 dormant crack(s) to propagate.

Collateral damage – cold slug of hot reheat steam or condensate caused a water hammer event due to failed non-return valve on cold reheat line. As a result, water made it into the HP turbine where it flashed and stretched the HP bonnet bolts and caused them to fail in tensile overload.

Water hammer event also caused turbine movement and cracked bearing #2 housing, which allowed about ~1,300 gallons of turbine lube oil (~20% capacity) to be released and then catch fire.

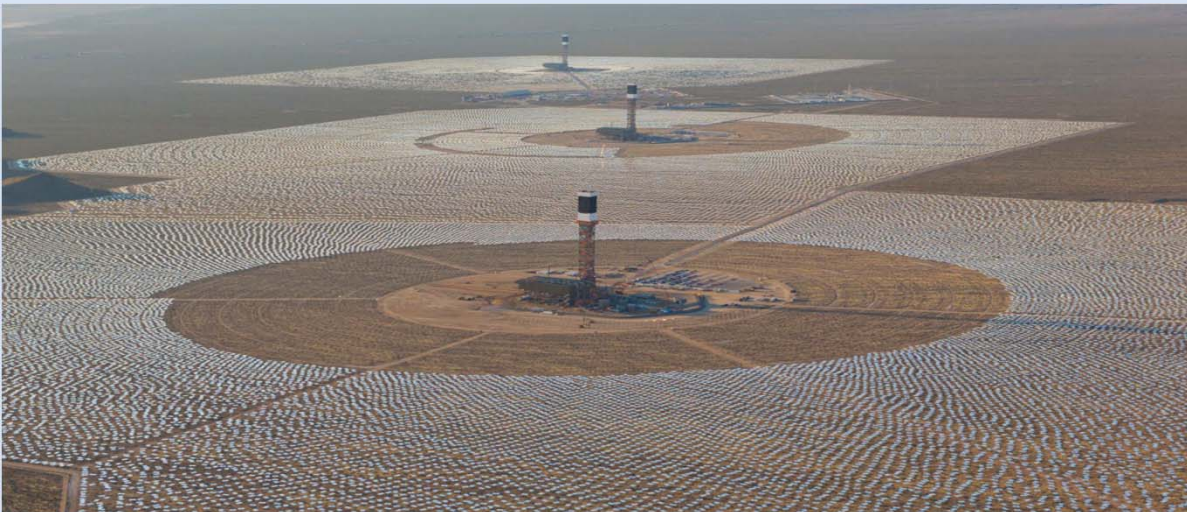
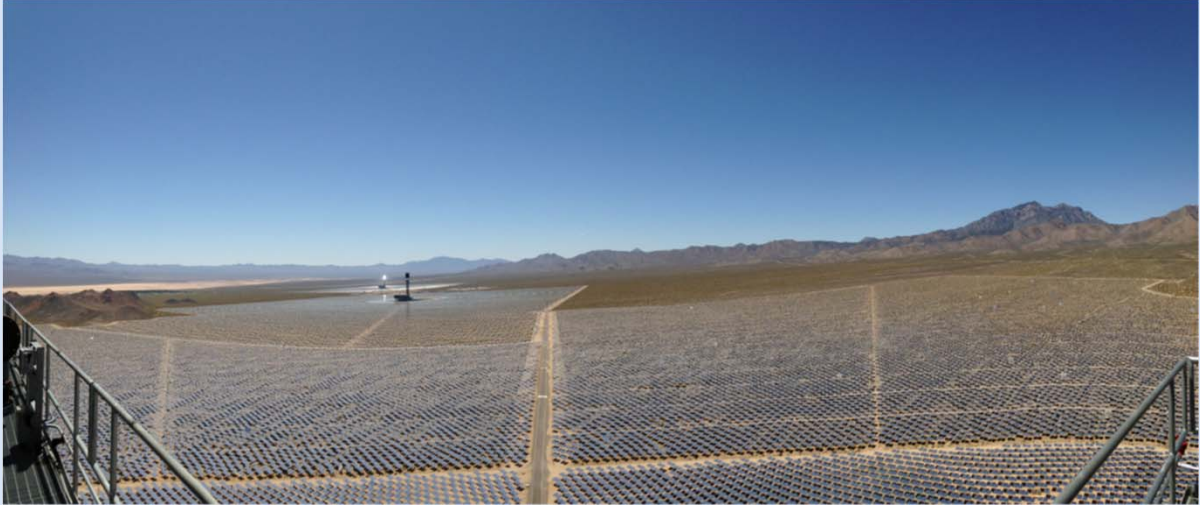
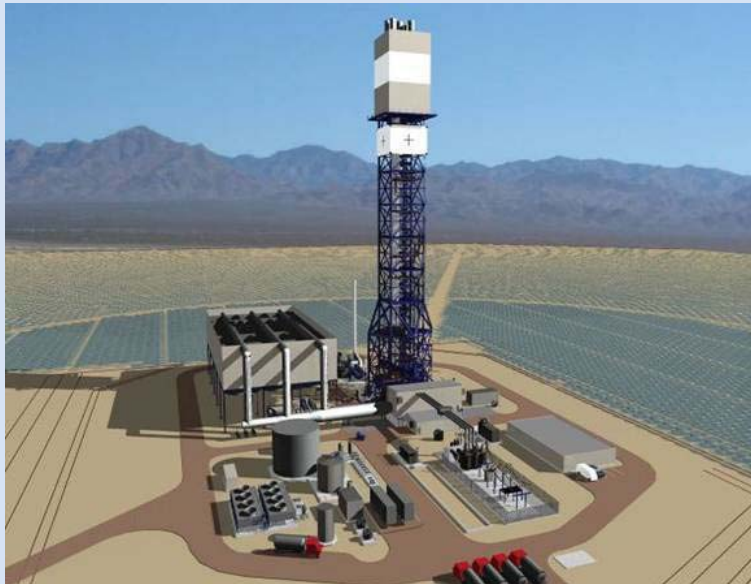
- Steam Turbine Generator (STG) – mechanical breakdown
 - 133 MW Siemens SST-900 turbine / SGEN 6-100A-2P generator (2012)
 - Through bolt failure in generator – replacement core available, rotor rewind
 - Claim settled: property damage \$14.4 million + business interruption \$6.5 million = \$20.9 million net
 - Deductibles = \$100,000 property damage, 45 days time element
 - No viable subrogation due to contractual provisions and expired warranty

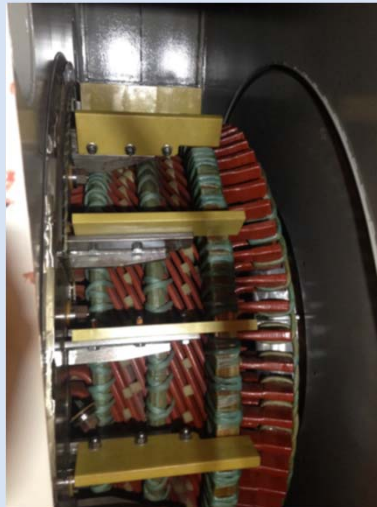
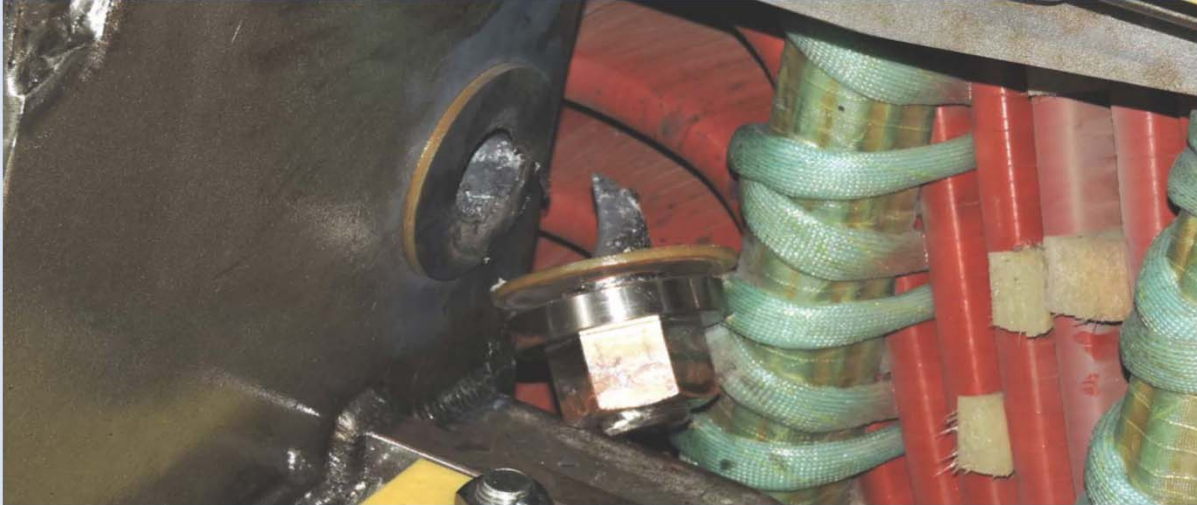
- Steam Turbine Generator (STG) – repair logistics
 - Insufficient egress from turbine building to remove large equipment
 - Entire roof had to be raised and walls stabilized
 - All cabling, fire suppression, lighting and piping above the unit had to be disassembled
 - Air shipment of 172,000-lb. replacement core from Germany = \$1.5 million: saved six weeks

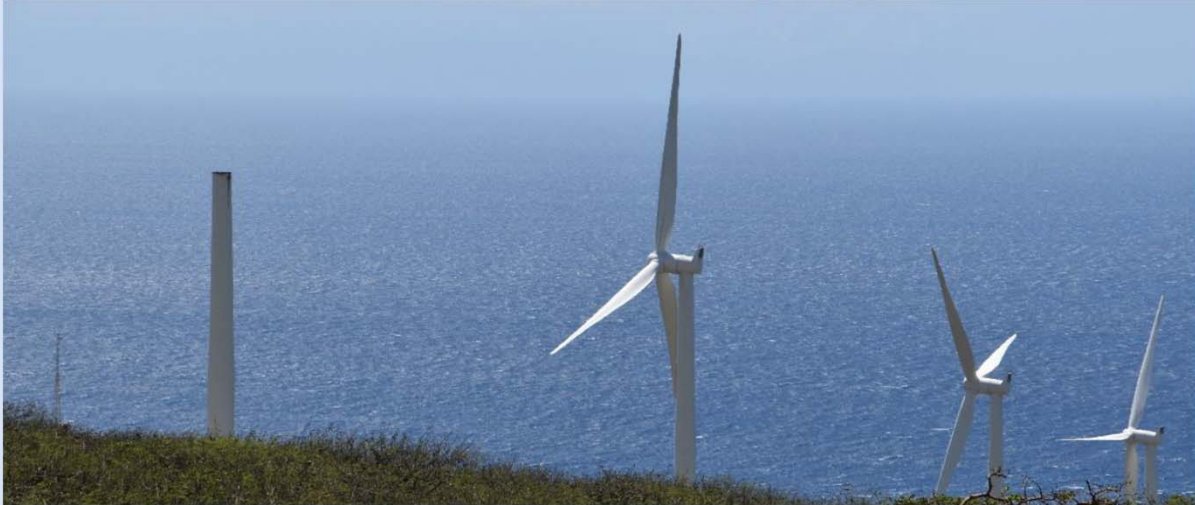
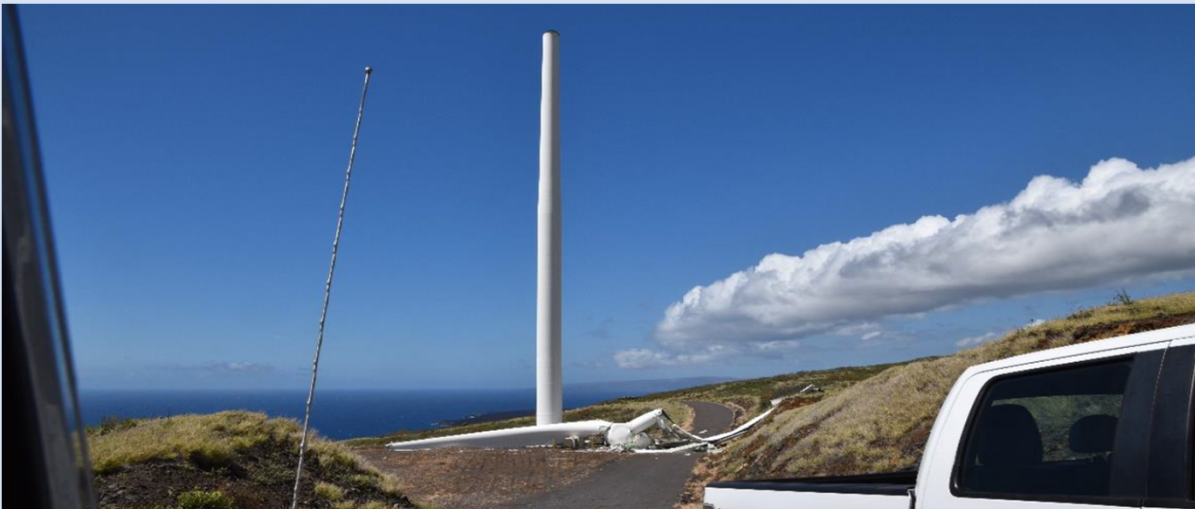
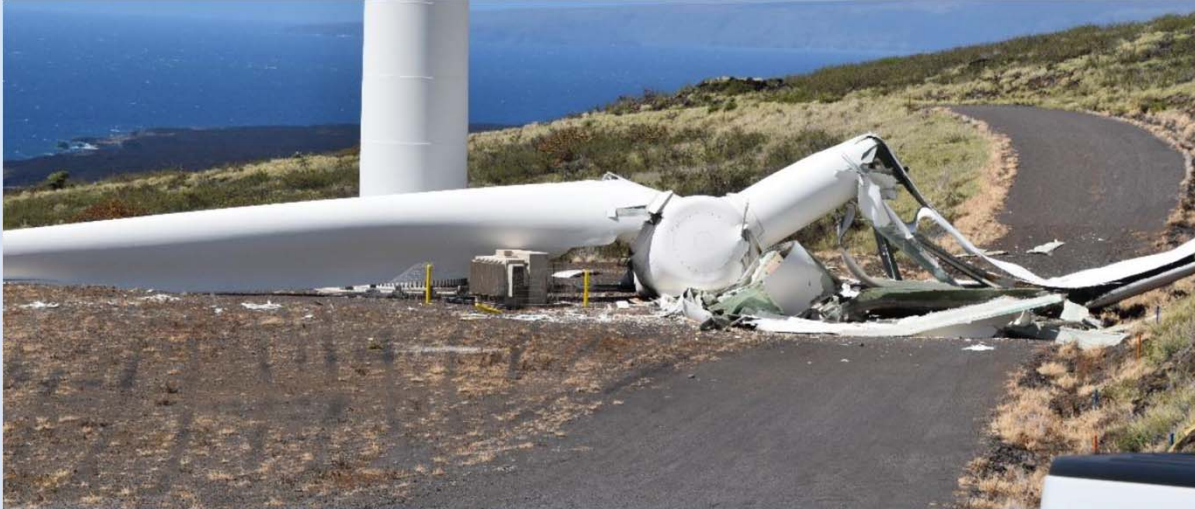
- Wind Turbine Generator (WTG) – mechanical breakdown
 - 8 x 3 MW Siemens D3 units (2012)
 - Nacelle fell to ground
 - Improper lubrication / anti-seize compound of yaw ring bolts during installation
 - Similar issue on other units corrected prior to any loss
 - Repair period = 17 months
 - Claim open – paid to date: \$8 million
 - Deductibles = \$100,000 property damage, 30 days time element
 - Subrogation and warranty claims remain under review

- Wind Turbine Generator (WTG) – repair logistics
 - Civil works estimated at \$3.5 million in remote location
 - Road preparation / grading / restoration – high spots lowered to accommodate transport of repair equipment and replacement blades – then had to be restored to original grade
 - Removal and reinstallation of traffic lights and signage as well as roadway center medians
 - Crane costs estimated at \$1.5 million – had to be sourced off-island
 - Tower replacement due to incompatibility with replacement nacelle
 - Overall repair costs approximately 2.5 times higher than original installation cost
 - Economy of scale – original costs allocated over eight units, repair costs over one unit

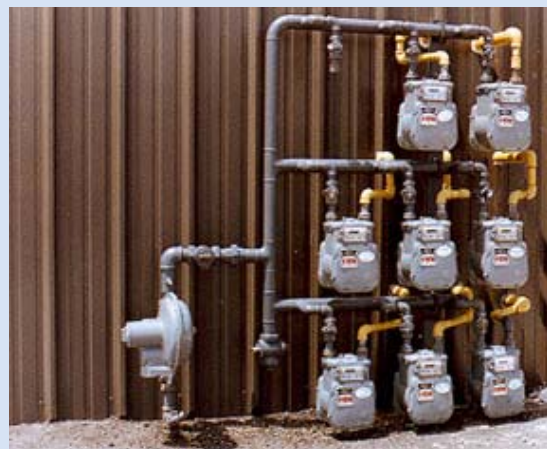
- The workers gained entrance to the basement and noticed that the meter for apartment 1F was spinning
- They locked out the 1st floor meters and again knocked on the doors of the first floor apartments
- They did not know how long the gas had been leaking
- They instructed one resident to open windows to ventilate, then returned to their truck
- 20 minutes later, the building exploded
