# Hardfacing Alloys Cracking and Disbonding in Steam Valves

## A Guide for AEGIS Members

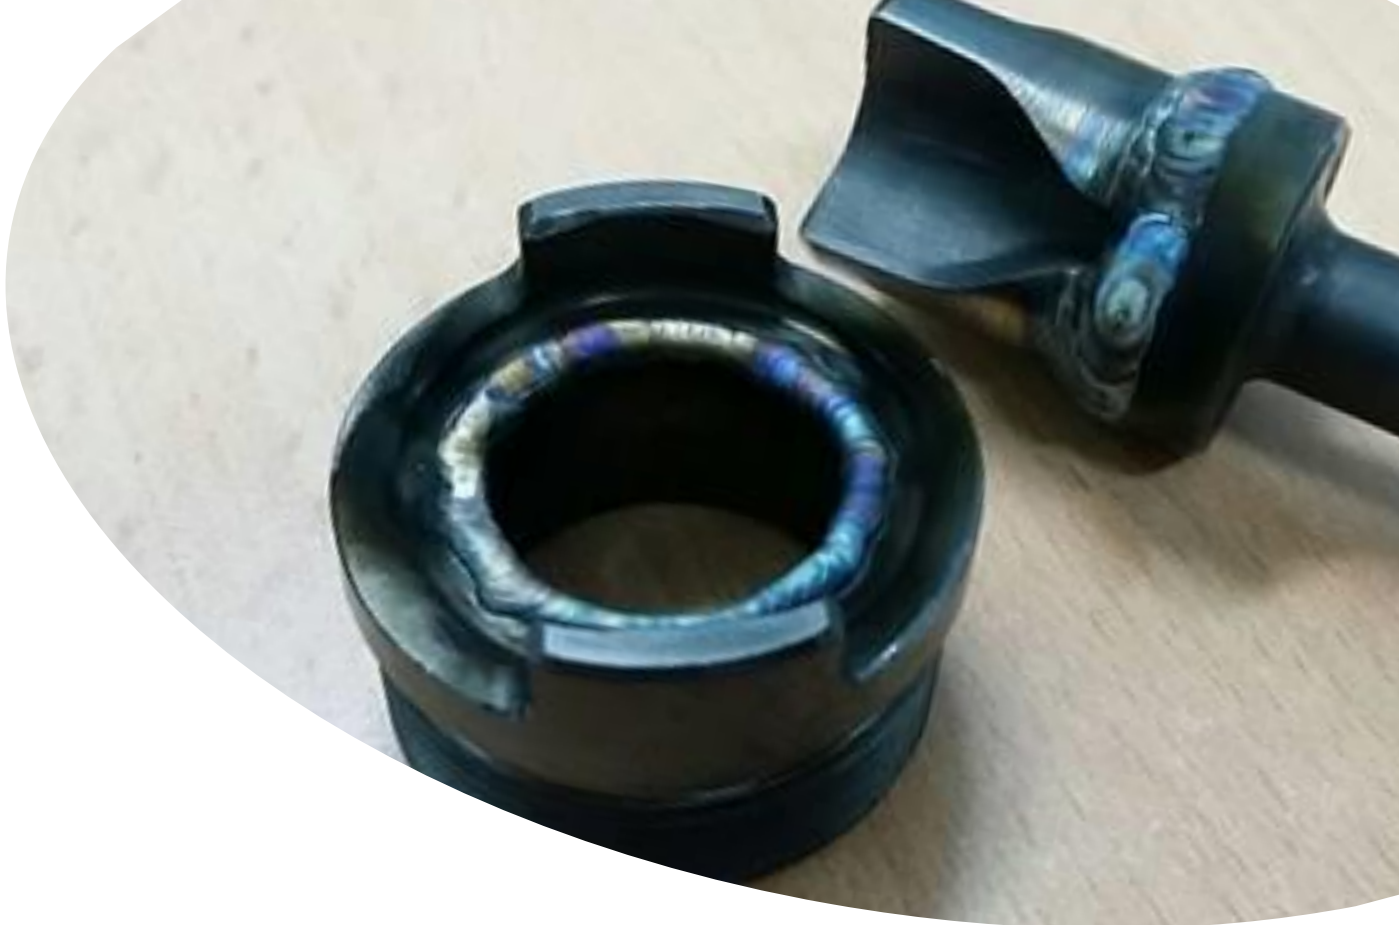
**Type 2 Transverse (Through Hardfacing) cracking**

Over time, cracks in the dilution layer propagate to create disbonded pieces of hardfacing that completely delaminate from the body of the valve or disc resulting in a valve that no longer isolates and allows loose material to flow downstream at high velocities and damage other equipment, including the steam turbine.

It is suggested that valves with Grade 91 bodies with Stellite hardfacing located in HP and HRH steam lines upstream of the turbine be replaced as soon as reasonably possible.
