Infrastructure Assessment

Sonic/Ultrasonic Testing Provides Reliable Condition Assessment

Nondestructive sonic/ultrasonic testing has been used to evaluate concrete properties for more than 60 years and to assess the structural condition of prestressed concrete cylinder pipe cores and coatings for more than 20 years.

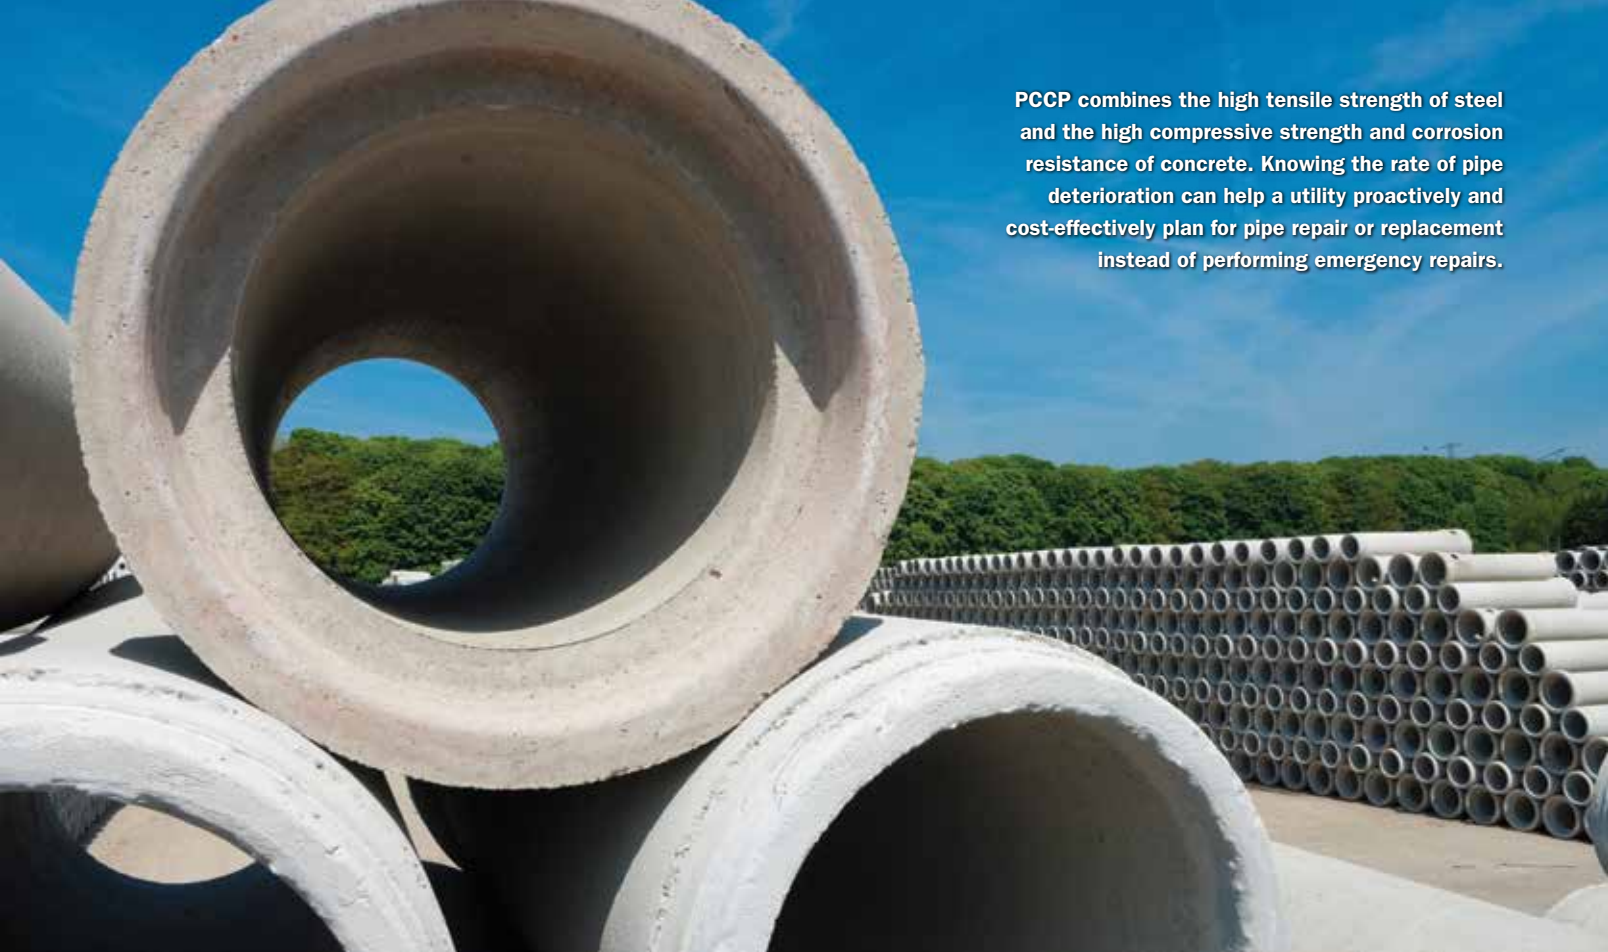
PCCP combines the high tensile strength of steel and the high compressive strength and corrosion resistance of concrete. Knowing the rate of pipe deterioration can help a utility proactively and cost-effectively plan for pipe repair or replacement instead of performing emergency repairs.

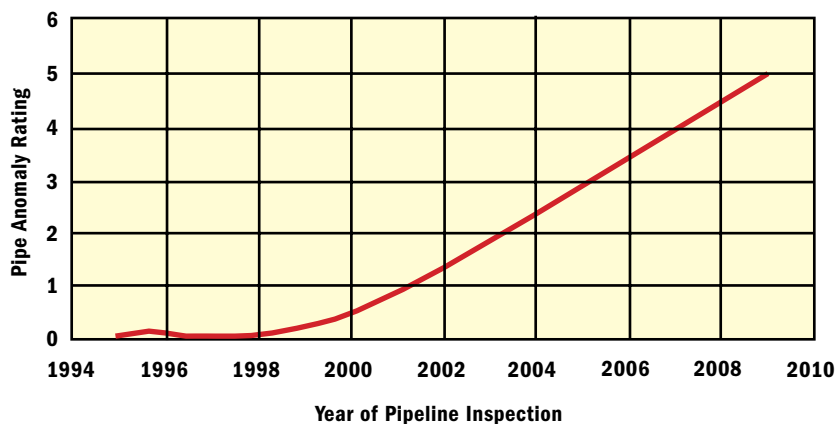
PCCP Decay vs. Time Curve (Pipe D397)

Periodic sonic/ultrasonic testing provides the data needed to develop a pipe decay curve vs. time chart.

A 96-in. prestressed concrete cylinder pipe (PCCP) installed in 1987 was tested in 1995, 2000, and 2009 using the sonic/ultrasonic method. The accompanying table shows a small portion of the reduced testing data. As shown in the table, the pipe contained no anomalies from the time of installation to the testing conducted in 2000. By the 2009 inspection, however, there was substantial deterioration, with Pipes D396 and D398 showing significant deterioration at the pipe ends. These pipes weren't excavated; however, based on similar anomalies of excavated pipe, about 2 ft of wire were significantly corroded, and the mortar coating was separated from the core.

Although a large portion of Pipe D397 had significant deterioration, the pipe wasn't excavated; however, based on excavation of similarly rated pipe, 3–4 ft of wire were corroded near the bottom of the pipe with possible delamination of the coating. Pipes D393, D394, D395, D396, and D398 were losing prestressing, and pipe D397 had lost a significant amount of wire prestressing.

The analysis indicates that pipe sections are aging, with an accelerating rate of deterioration.
